DITCHING INVESTIGATION OF A DYNAMIC MODEL
OF A HU2K-1 HELICOPTER

By William C. Thompson

Langley Research Center
Langley Air Force Base, Va.

TECHNICAL MEMORANDUM SX-626

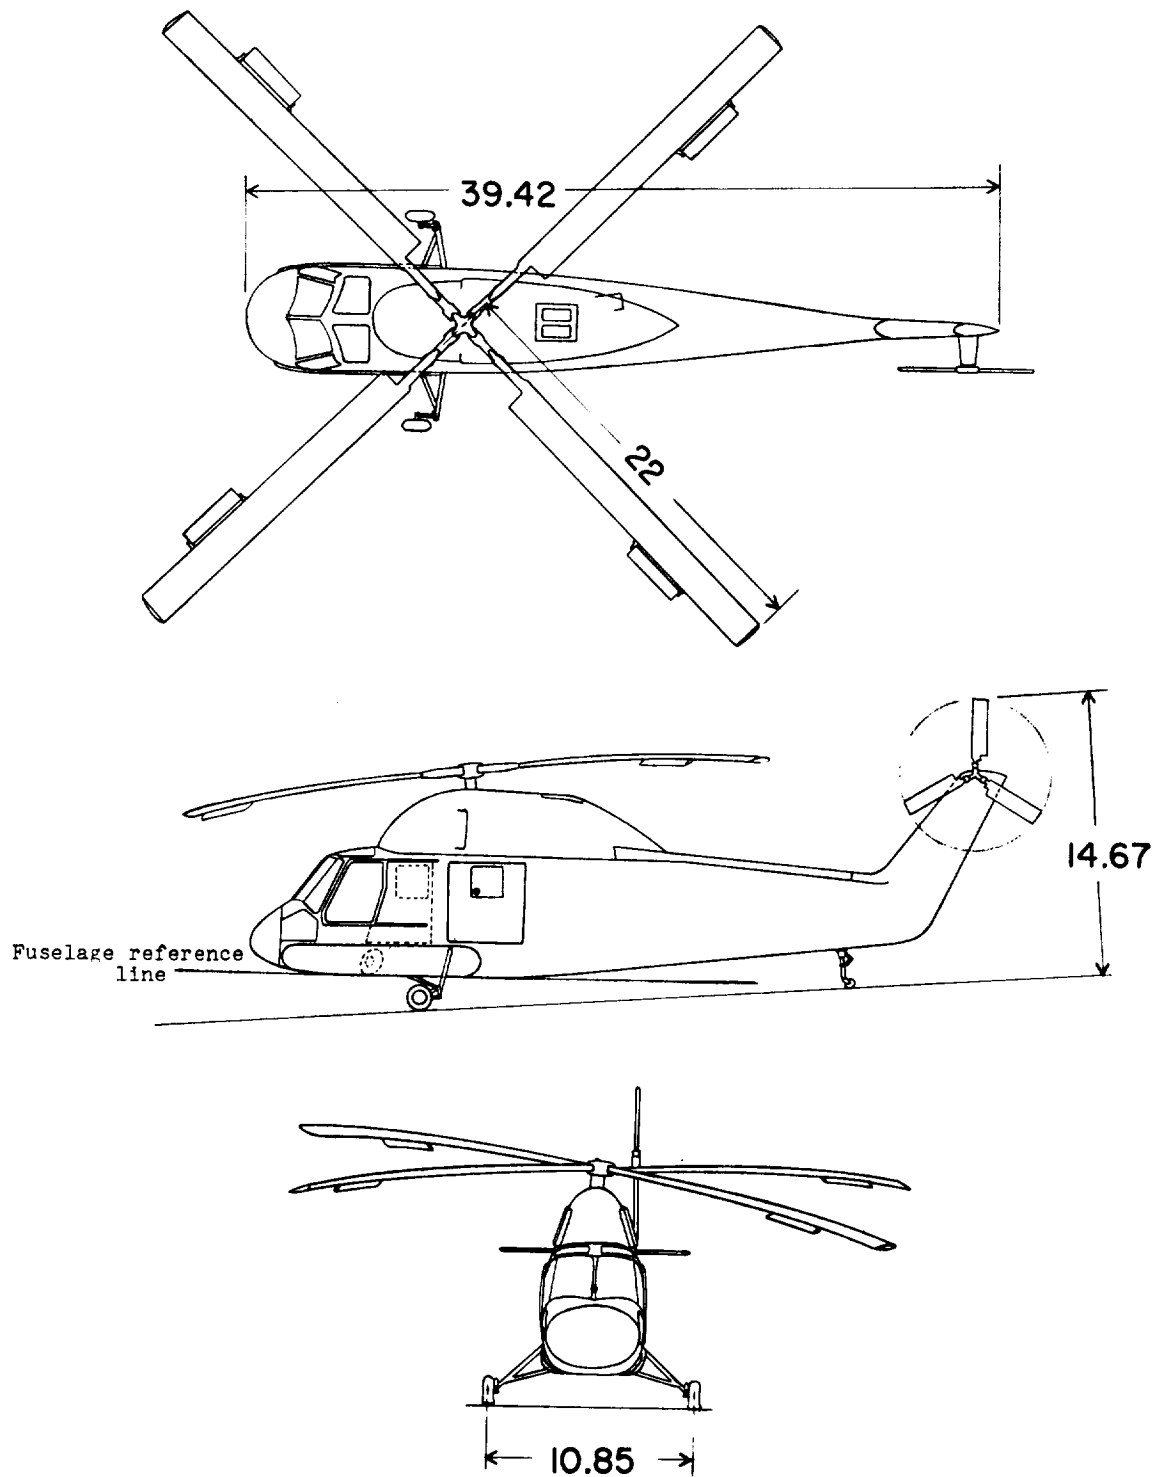
Figure 1.- Three-view drawing of the HU2K-1 helicopter. Dimensions are in feet, full scale.

The general arrangement of the HU2K-1 helicopter is shown in figure 1. A ditching investigation of a 1/9-scale dynamic model was conducted at the monorail apparatus of the Langley impacting structures facility. Tests were made in calm and rough water with various model configurations and landing attitudes and at various speeds. Certain portions of the model were made approximately scale-strength to determine the probable ditching behavior and to some extent the resultant damage. Data were obtained from visual observations, acceleration records, and motion pictures.

Accelerations were measured by single-component strain-gage accelerometers installed in the pilot's compartment. The natural frequencies of the accelerometers and the recording galvanometers were 160 and 150 cycles per second, respectively. Both were damped to about 70 percent of critical damping, and the reading accuracy of the instrument was $\pm 0.1g$. The longitudinal decelerations and the normal accelerations were measured parallel and perpendicular, respectively, to the fuselage reference line (fig. 1). The static normal-accelerometer reading was $1g$.

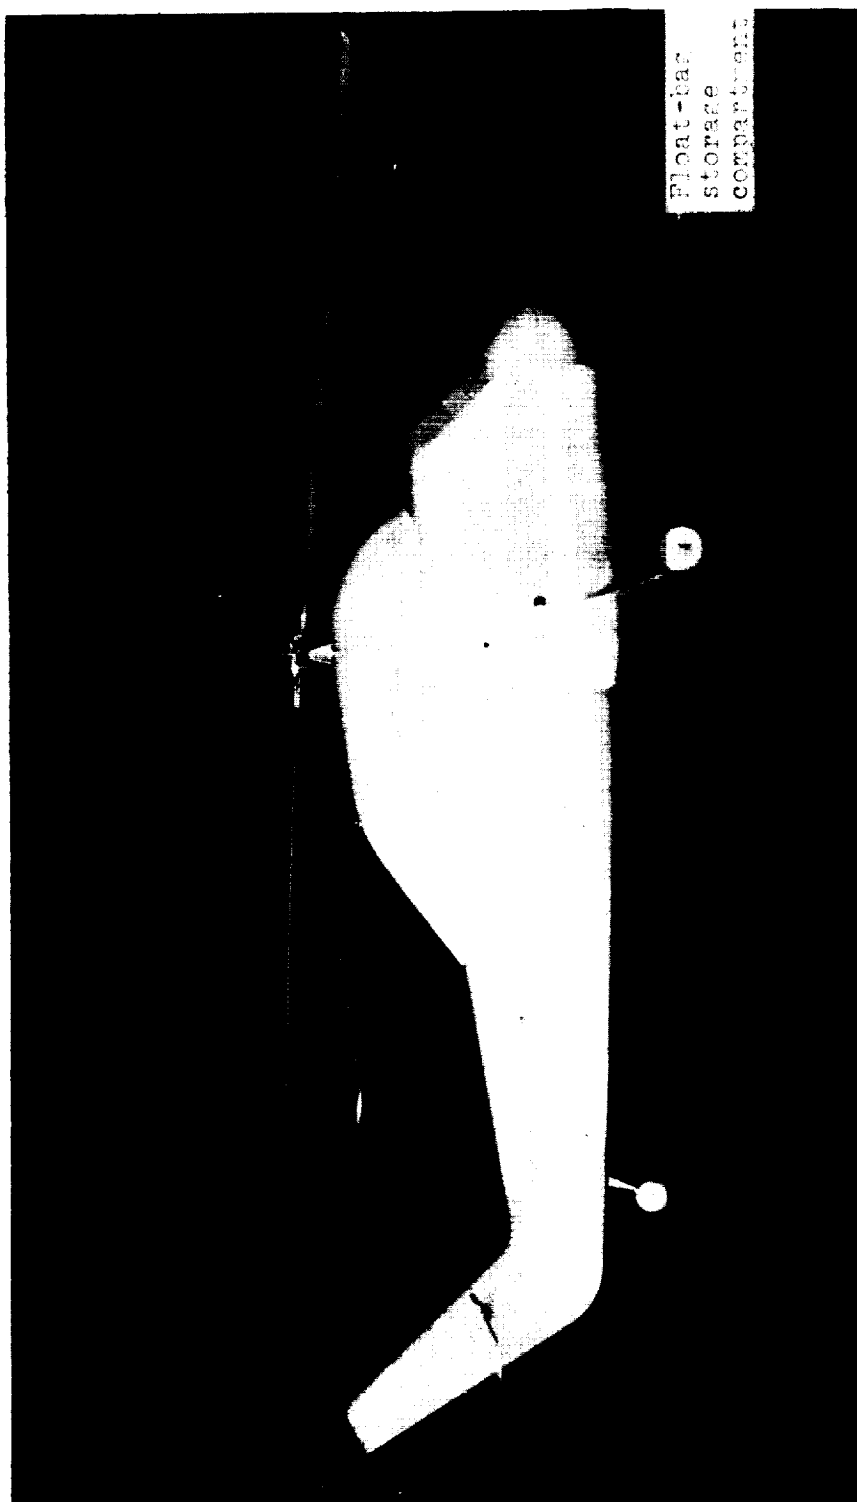
(a) Side view. I-61-7706

Figure 2.- Model with landing gear extended.

The 1/9-scale dynamic model of the HU2K-1 helicopter (fig. 2) was furnished by the U.S. Navy. The model was constructed principally of glass cloth impregnated with plastic. Internal ballast was used to obtain scale weight and scale moments of inertia. The scale relationships used in this investigation are shown in table I. Pertinent characteristics of the model and full-scale helicopter are given in table II.

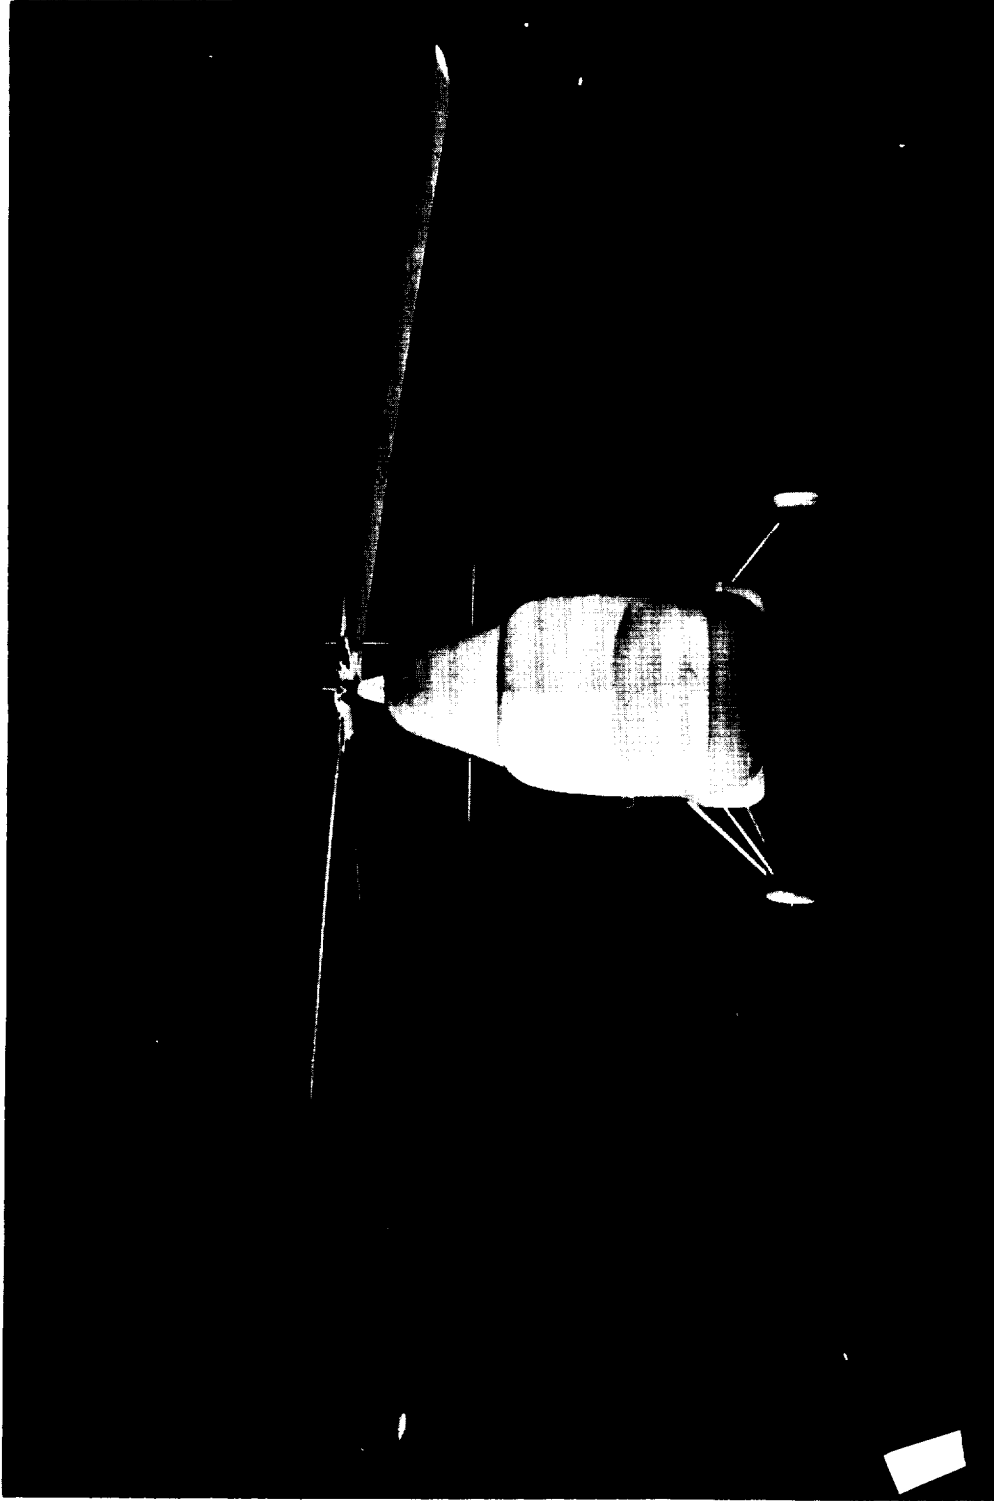
(b) Front view. L-58-440a

Figure 2.- Continued.

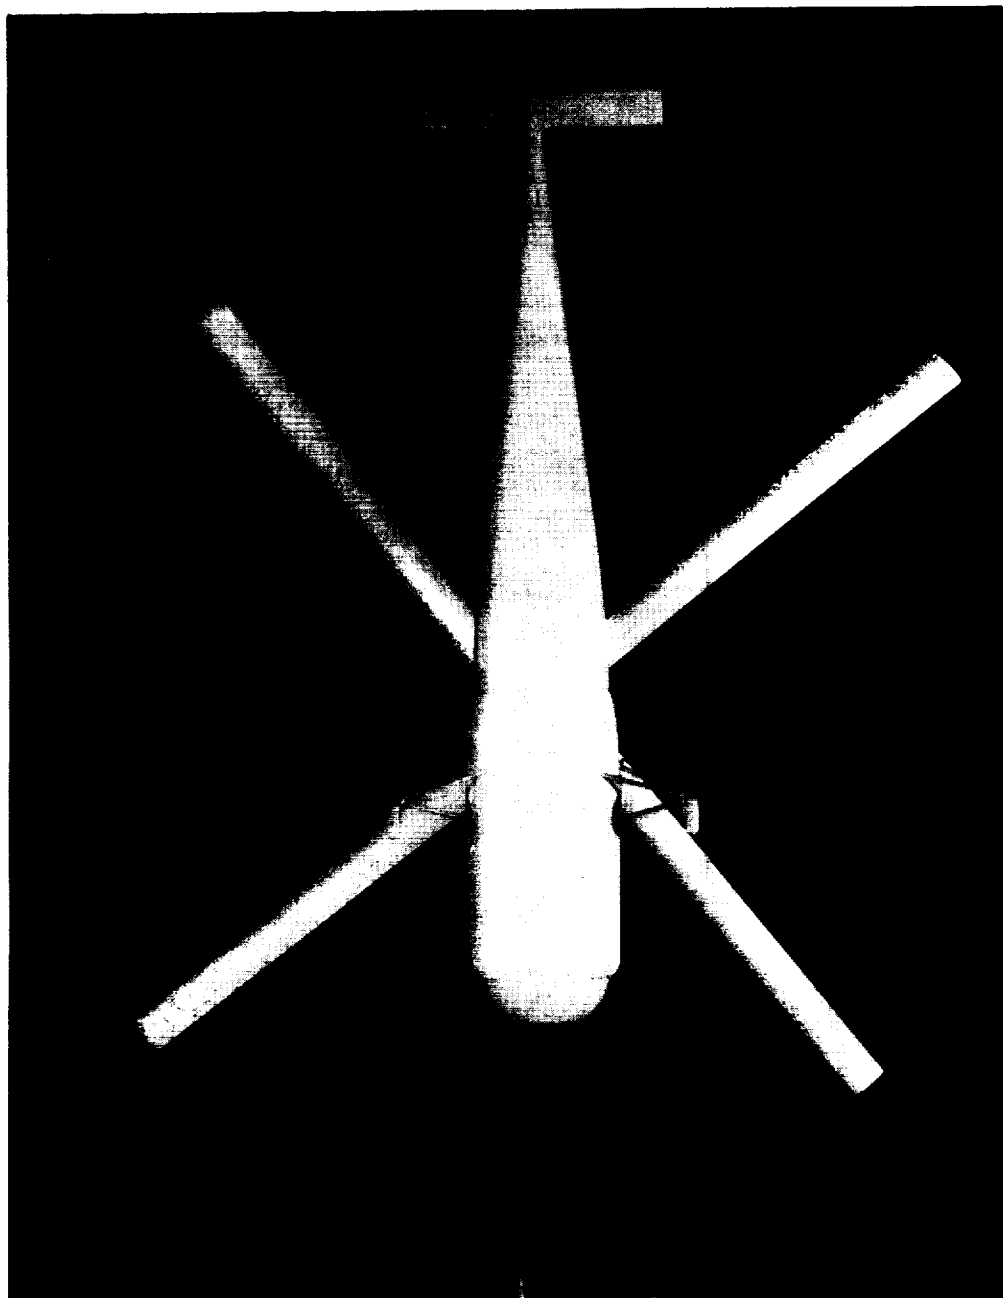
(c) Bottom view. L-58-439a

Figure 2.- Concluded.

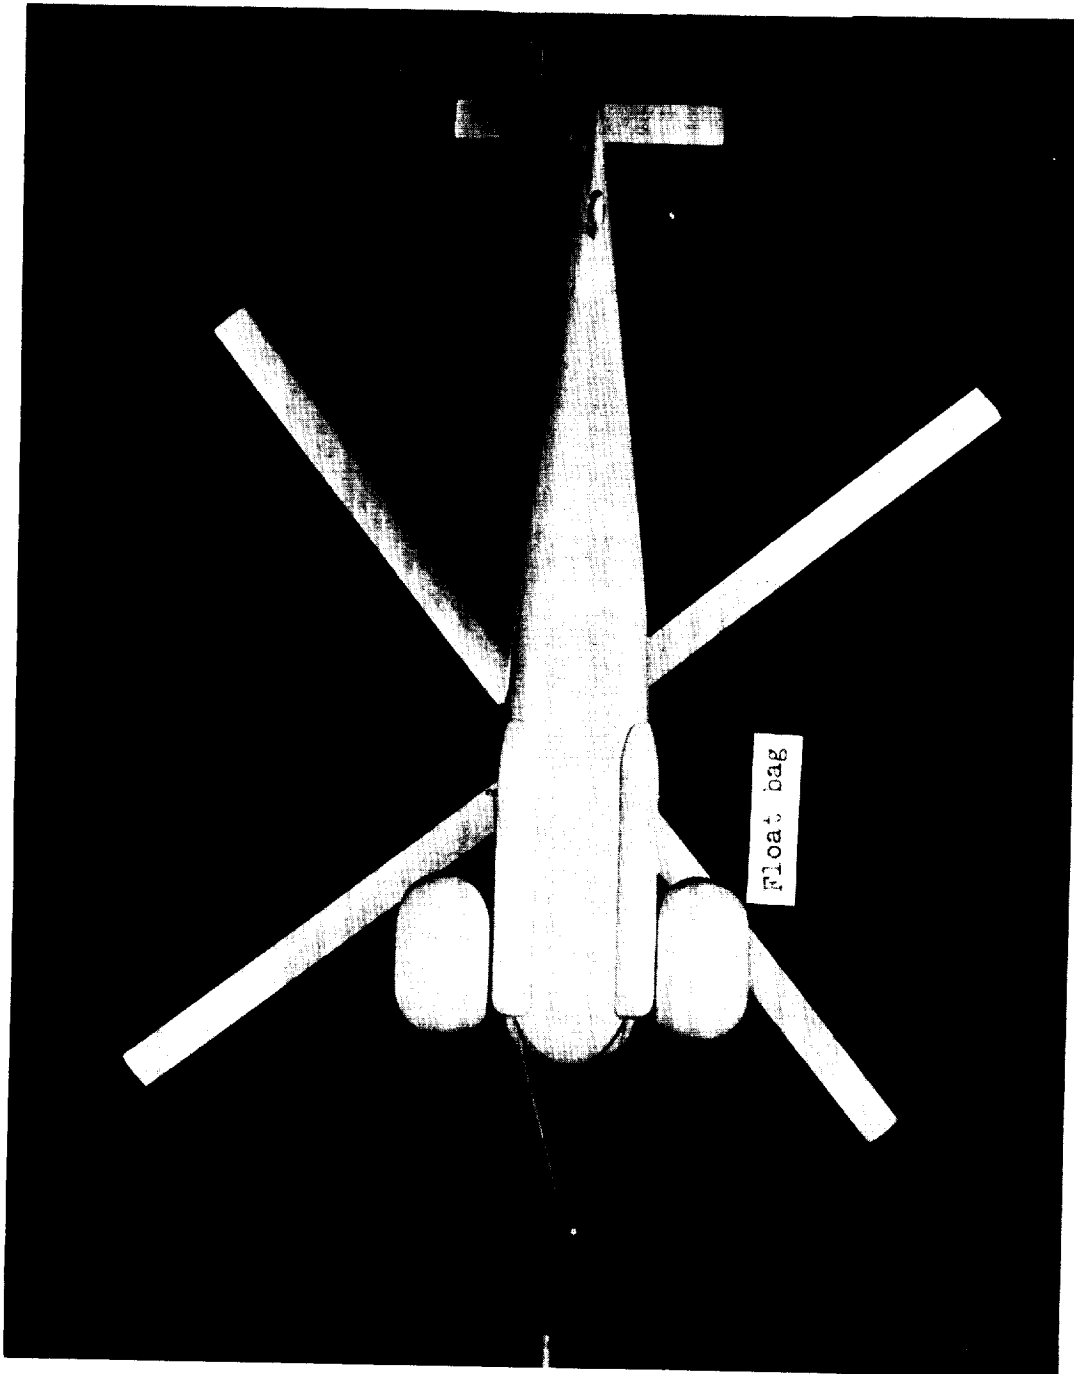
Figure 3.- Model with float bags inflated. L-61-7707

The float bags shown on the model in figure 3 (stored condition simulated in fig. 2) are a part of the original helicopter design and are to be inflated when a ditching is imminent.

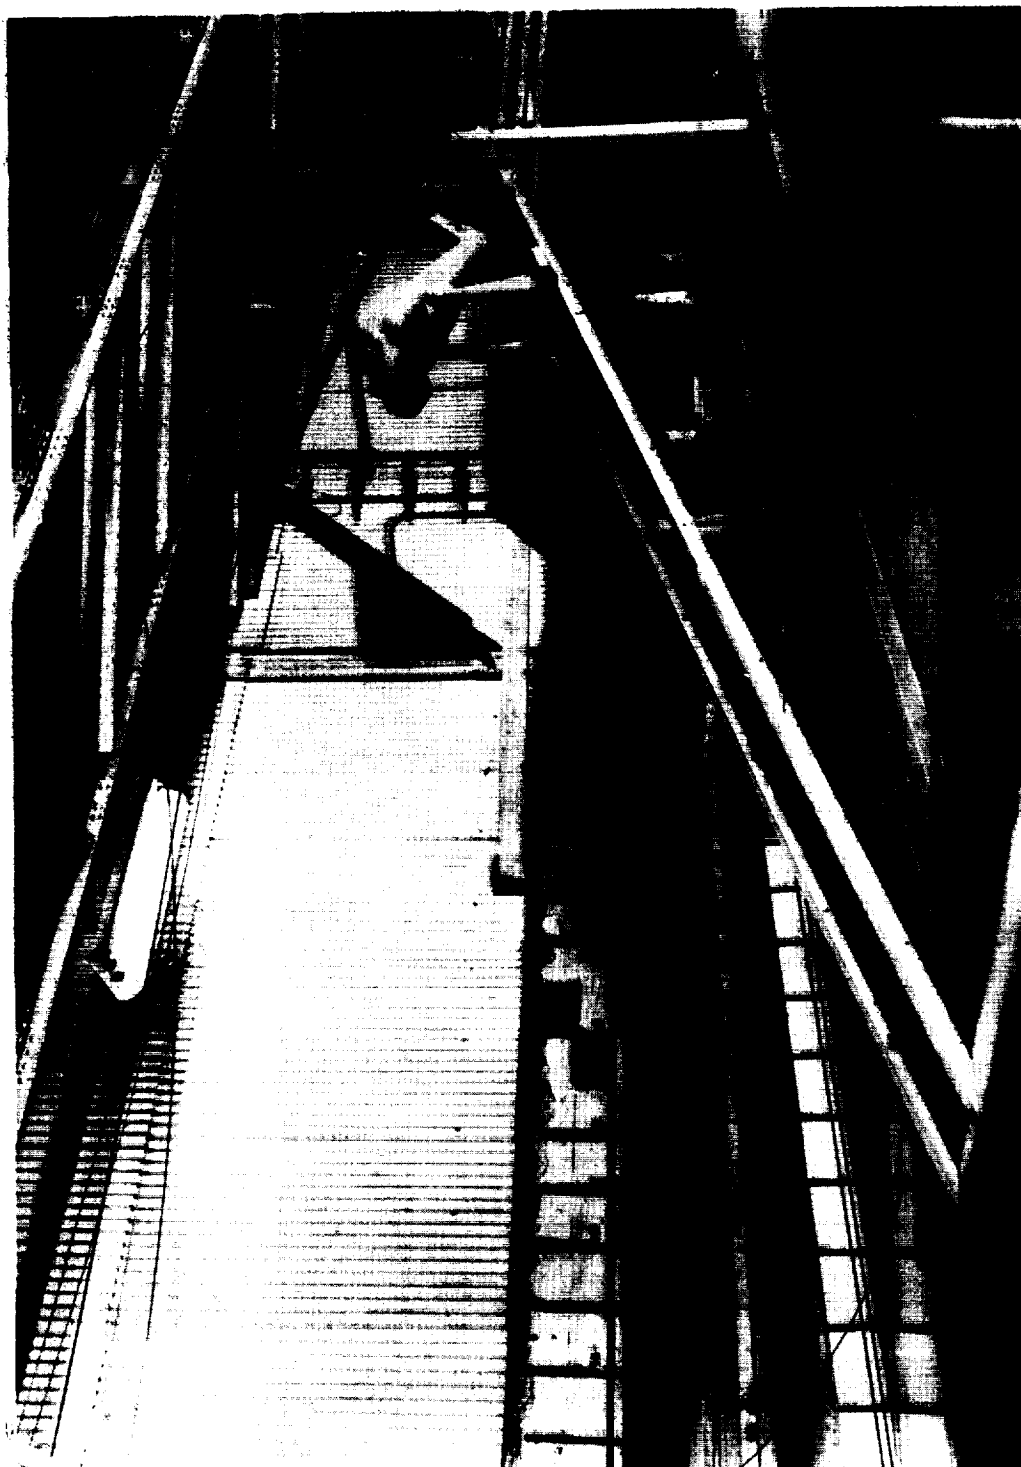
Figure 4.- Setup for helicopter model ditching tests at the monorail apparatus.

A special test setup was used in this investigation in order to have the model enter the water as a free body at controlled attitudes and speeds with the rotor turning. Figure 4 shows the launch track set at an angle to give the model the desired horizontal and vertical velocity components to simulate a condition in which a pilot flared the vehicle too late. The launch track was not required for the tests in which the model had only vertical velocity (simulating a condition in which the pilot flared the vehicle too early). For the tests with only vertical velocity, the model was suspended above the water at the desired landing attitude and was allowed to fall freely into the water. For all tests a motor drive unit was located just above the rotor hub and was used to bring the rotor up to the desired speed of rotation (scaled tip speed). The motor drive unit was disengaged just prior to launching the model, and the rotor autorotated during the ditching.

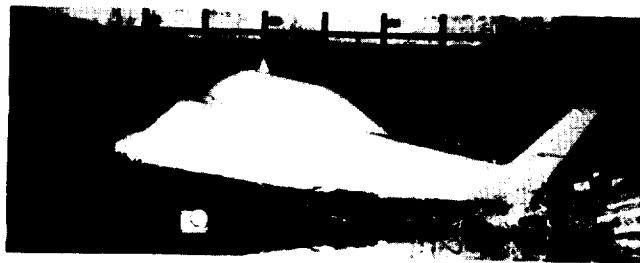
(a) Near contact.

(b) Rear fuselage sank.

(c) Model pitched forward.

(d) Rolled 90°, remained on side.

Figure 5.- General behavior sequence for a model ditching without float bags.

The late-flare ditchings of the model were fairly smooth operations. The model without the float bags penetrated the water deeply soon after initial contact, and then surfaced and rolled over on its side. The distance of the run was about 100 feet from initial water contact to roll-over. Typical sequence photographs of this behavior are shown in figure 5. Scale-strength fuselage bottoms showed considerable skin buckling, but there were only minor ruptures. An illustrative photograph of the damage is shown in figure 7(a). The maximum normal acceleration was about 7.3g and the average maximum longitudinal acceleration was about 1.6g (table III). Typical acceleration curves are shown in figure 8(a).

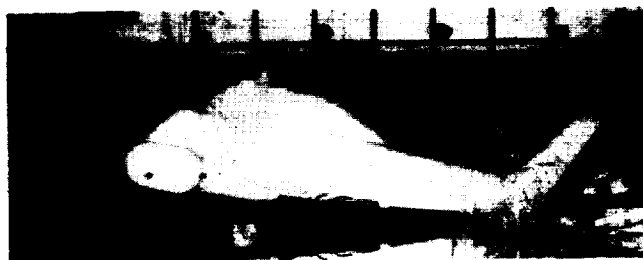
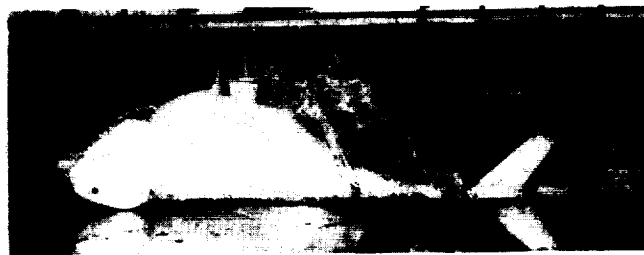
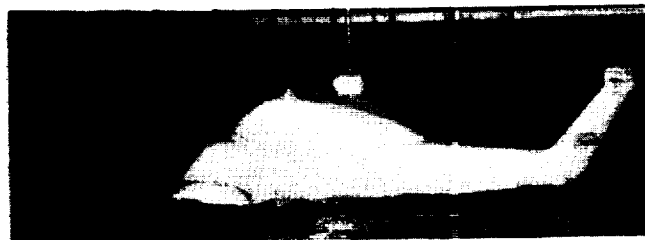
(a) Near contact.

(b) Rear fuselage sank.

(c) Float bags support forward fuselage.

(d) Model remained upright.

Figure 6.- General behavior sequence for a model ditching with float bags inflated.

When the model was ditched with the float bags inflated, the aft portion of the fuselage penetrated the water much more deeply than the nose portion. The model came to a stop about 150 feet after initial water contact and remained upright in a near-level attitude. This sequence of events is illustrated in figure 6. The average maximum normal acceleration was about 6.8g and the average maximum longitudinal acceleration was about 1.6g (table III). With the float bags inflated, damage to the scale-strength fuselage bottom consisted principally of buckled skin with only slight ruptures. Typical damage is illustrated in figure 7(b).

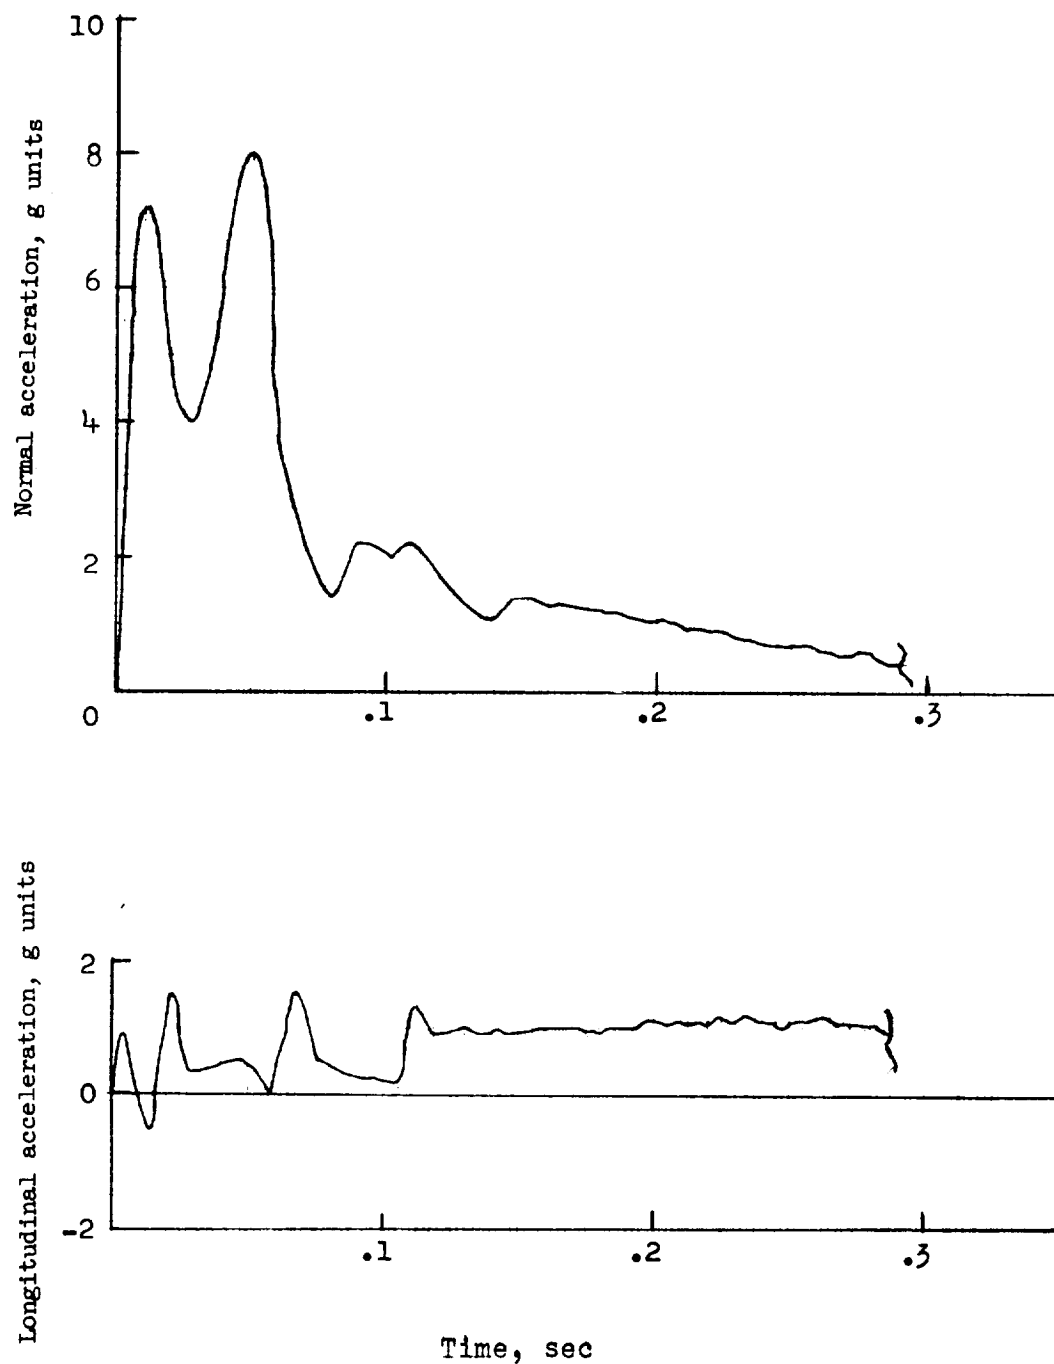
(a) Without float bags.

Figure 8.- Typical touchdown acceleration curves for late-flare ditchings in calm water. Scale-strength fuselage bottom installed on model. All values are full scale.

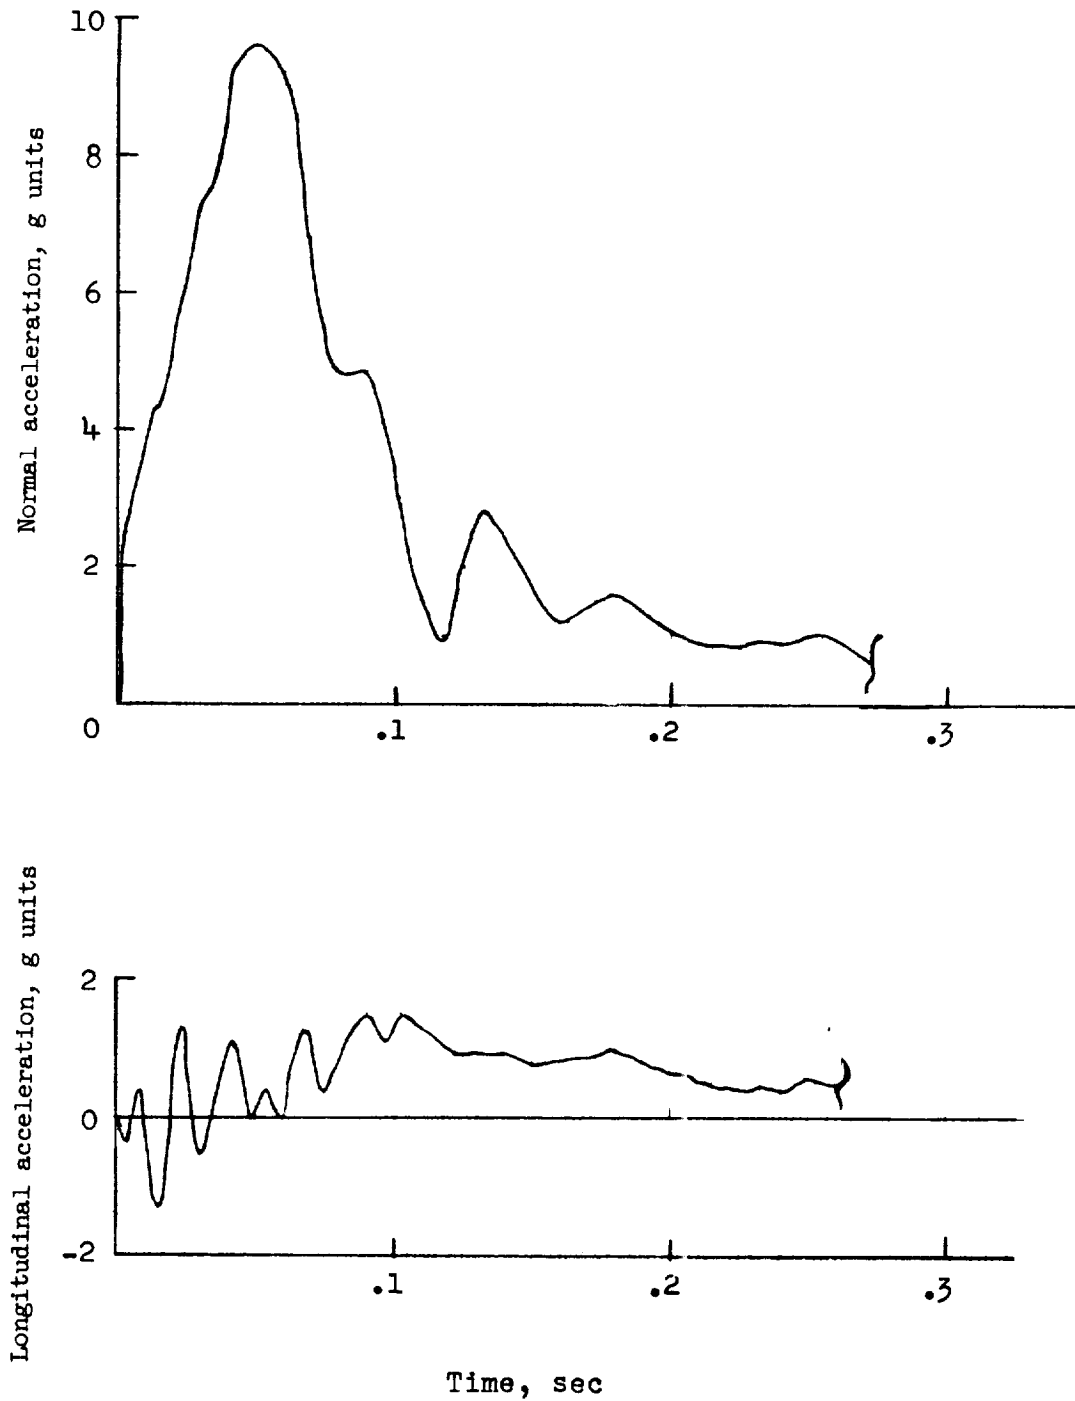
(b) With float bags inflated.

Figure 8.- Concluded.
